MARITIME HERITAGE RESOURCES

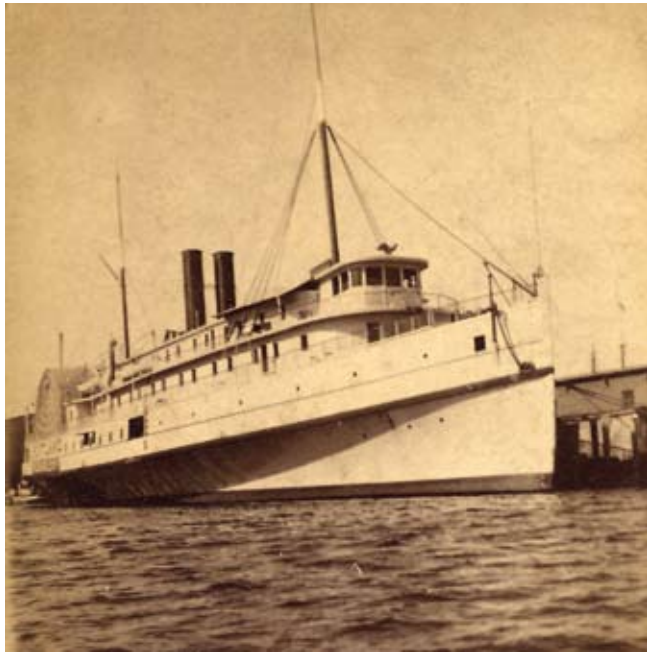
FIGURE 76. THE STEAMSHIP *PORTLAND*'S LOCATION IN THE SANCTUARY WAS CONFIRMED BY NOAA SCIENTISTS IN 2002.

Depicted here is a side scan sonar image of the *Portland* showing it sitting upright on its keel with boiler uptakes and walking beam engine projecting above the main deck. Courtesy: Klein Sonar Associates, Inc.

Remains of the *Portland* include its upright and intact wooden hull, which has survived from the main deck level down to the keel (Figure 76). Machinery assemblages such as the boilers, paddle flanges and shaft, steam engine, walking beam and wooden A-frame are articulated and in their original positions. Smaller cultural artifacts such as plates and

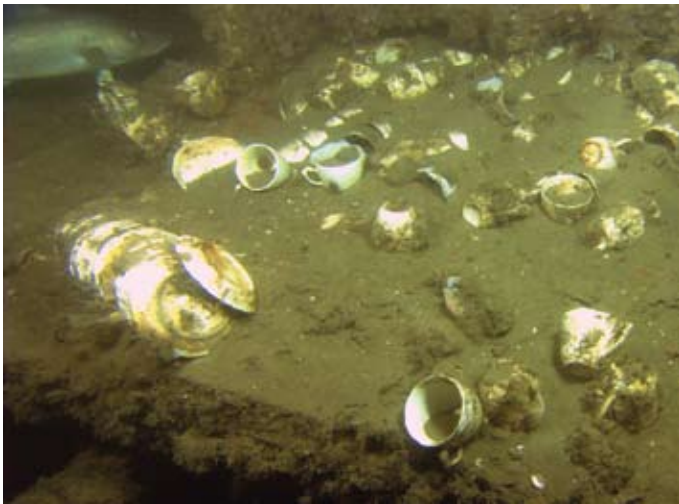
FIGURE 77. FRAGILE TEACUPS AND DISHWARE IN THE GALLEY SURVIVED THE *PORTLAND*'S PLUMMET TO SEAFLOOR IN 1898.

The shipwreck is listed on the National Register of Historical Places and is the best preserved of any New England “night boat” found to date. Source: NOAA/SBNMS, NURC-UConn, and the Science Channel.

cups lie scattered inside and outside the hull (Figure 77). The *Portland*'s hull is draped with fishing nets and provides substrate for sponges and anemones. In 2005, the *Portland* was listed on the National Register of Historic Places.

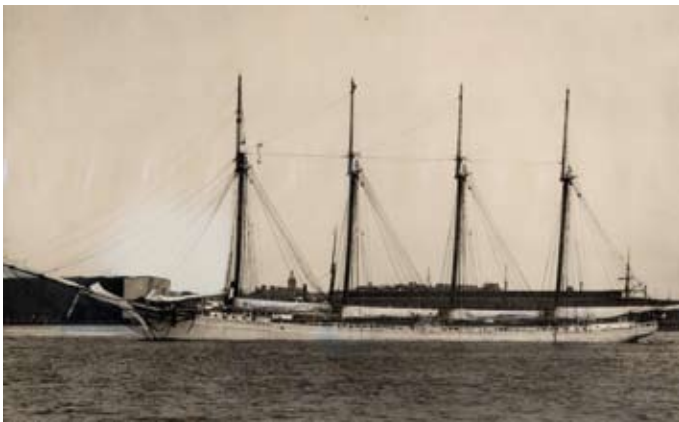
FIGURE 79. HISTORICAL PHOTOGRAPH OF THE 5-MASTED COAL SCHOONER *LOUISE B CRARY*.

In 1902, the *Louise B. Crary*’s mate miscalculated his tack causing his vessel to strike the *Frank A. Palmer*’s bow. Courtesy: Maine Maritime Museum.

Another visually spectacular shipwreck site is the wrecks of the 83.5-m (274 ft.) long 4-masted schooner *Frank A. Palmer* (Figure 78) and 81.4-m (267 ft.) long 5-masted schooner *Louise B. Crary* (Figure 79), which sit upright on the seafloor connected at their bows after colliding (Figure 80). Both vessels were built at the turn of the century in Bath, Maine, for the coal trade between the Chesapeake Bay and New England. While enroute to Boston, Massachusetts, from Hampton Roads, Virginia, with coal cargos, the *Frank A. Palmer* and *Louise B. Crary* collided on December 17, 1902. Eleven of the twenty-one sailors onboard the schooners perished during the accident or while awaiting rescue in a lifeboat. Both schooners are intact from keel to main deck and have portions of their masts still standing. Surveys have encountered cultural artifacts within the remains of the *Frank A. Palmer* captain's cabin (Figure 81). In 2006, the *Frank A. Palmer* and *Louise B. Crary* were listed on the National Register of Historic Places.

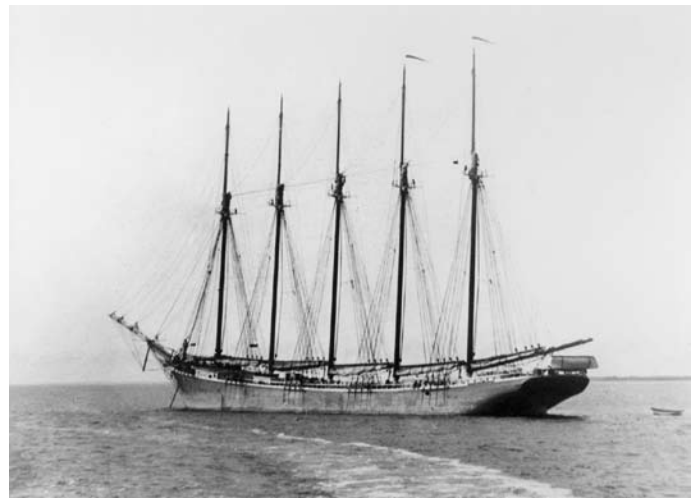
FIGURE 80. IN 2002, NOAA SCIENTISTS CONFIRMED THE LOCATION OF THE SCHOONERS *FRANK A. PALMER* AND *LOUISE B. CRARY* IN THE STELLWAGEN BANK SANCTUARY.

Depicted is a side-scan sonar image of the two intact vessels, connected at their bows, in the same orientation in which they sank. Source: NOAA/SBNMS and NURC-UConn.

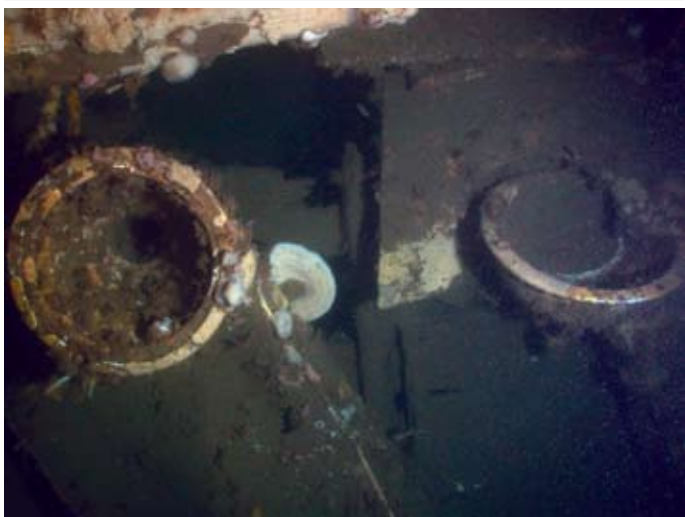
FIGURE 81. THE *FRANK A. PALMER*'S STERN CABIN CONTAINS THE REMAINS OF THE CAPTAIN'S SINK AND TOILET.

The *Frank A. Palmer* and *Louise B. Crary* are listed on the National Register of Historic Places and are the best preserved examples of New England coal schooners in the archaeological record located thus far. Source: NOAA/SBNMS and NURC-UConn.

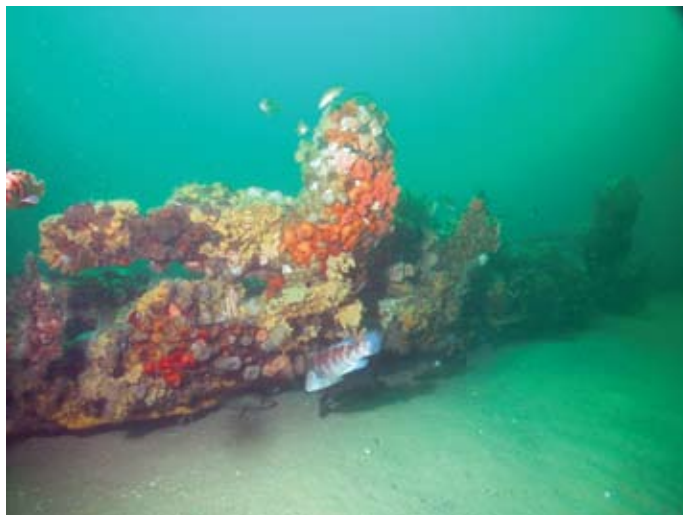
FIGURE 83. THE *PAUL PALMER* RESTS ON TOP OF STELLWAGEN BANK WITH ITS WOODEN FRAMES AND HULL PLANKING PROTRUDING UP FROM THE SAND.

Substantial information can be learned about the role coal schooners played in the growth of New England by examining *Paul Palmer's* archaeological remains. Source: NOAA/SBNMS.

Today, the *Paul Palmer*’s remains consist of its wooden hull, intact to the turn of the bilge, keelsons, a pile of anchor chain and the schooner’s windlass (Figure 83). Ship fittings, such as bits, a davit, anchors and rigging components, lie throughout the site. While the fire likely destroyed much of the vessel’s hull, the dynamic environment on top of

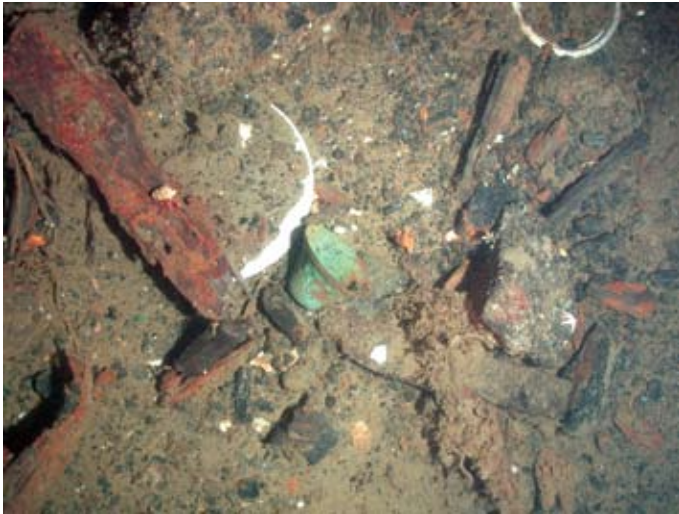
FIGURE 84. ARTIFACTS, SUCH AS THE BRASS HAND BELL AND CERAMIC DISHES SEEN HERE, ARE WELL PRESERVED ON THIS WOODEN HULLED SHIPWRECK WITH A COAL CARGO.

The sanctuary is studying this vessel to discover its identity and learn about life onboard a merchant sailing vessel in the New England coasting trade. Source: NOAA/SBNMS and NURC-UConn.

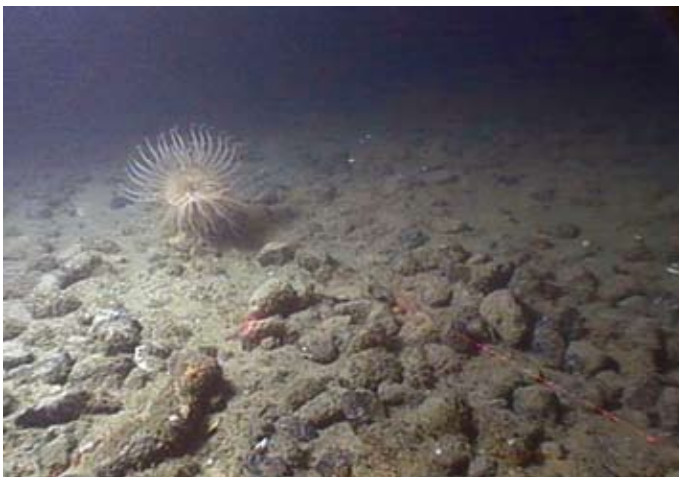
FIGURE 85. THE COAL CARGO DEPICTED IN THIS PHOTOGRAPH COVERS THE REMAINS OF A SHIPWRECK.

Bottom trawling has destroyed the vessel's structure above the sediment and removed all the durable artifacts, such as anchors and iron fittings. Source: NOAA/SBNMS and NURC-UConn.

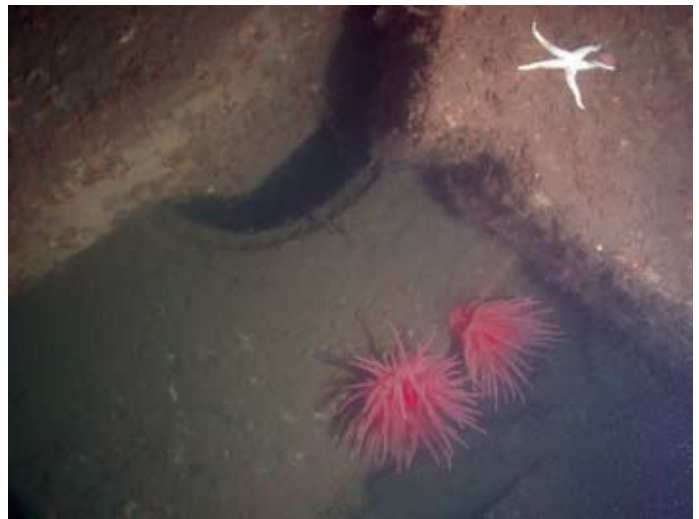
FIGURE 86. THIS SHIPWRECK'S GRANITE BLOCK CARGO WAS DESTINED FOR USE IN THE CONSTRUCTION OF SIDEWALKS AND SEWER SYSTEMS.

Granite transportation supported a large fleet of sailing vessels during the 19th and early 20th centuries. Source: NOAA/SBNMS and NURC-UConn.

The granite industry is another coastal trade represented by a sanctuary shipwreck. In the remains of this sailing vessel, the cargo of granite slabs vary in size, ranging from blocks measuring 2 m long by .5 m wide, to others stretching over 3 m long. Approximately 40 slabs were contained within the vessel's hold (Figure 86). The most common slab shape measures 3 m long by 2 m wide with a manhole bored into its center. Blocks of this variety were used to cover sewer basins that captured the drainage from street gutters. The uniform shape of the manholes suggests that they were bored using a large diameter drill, a technology first used in the second half of the 19th century.

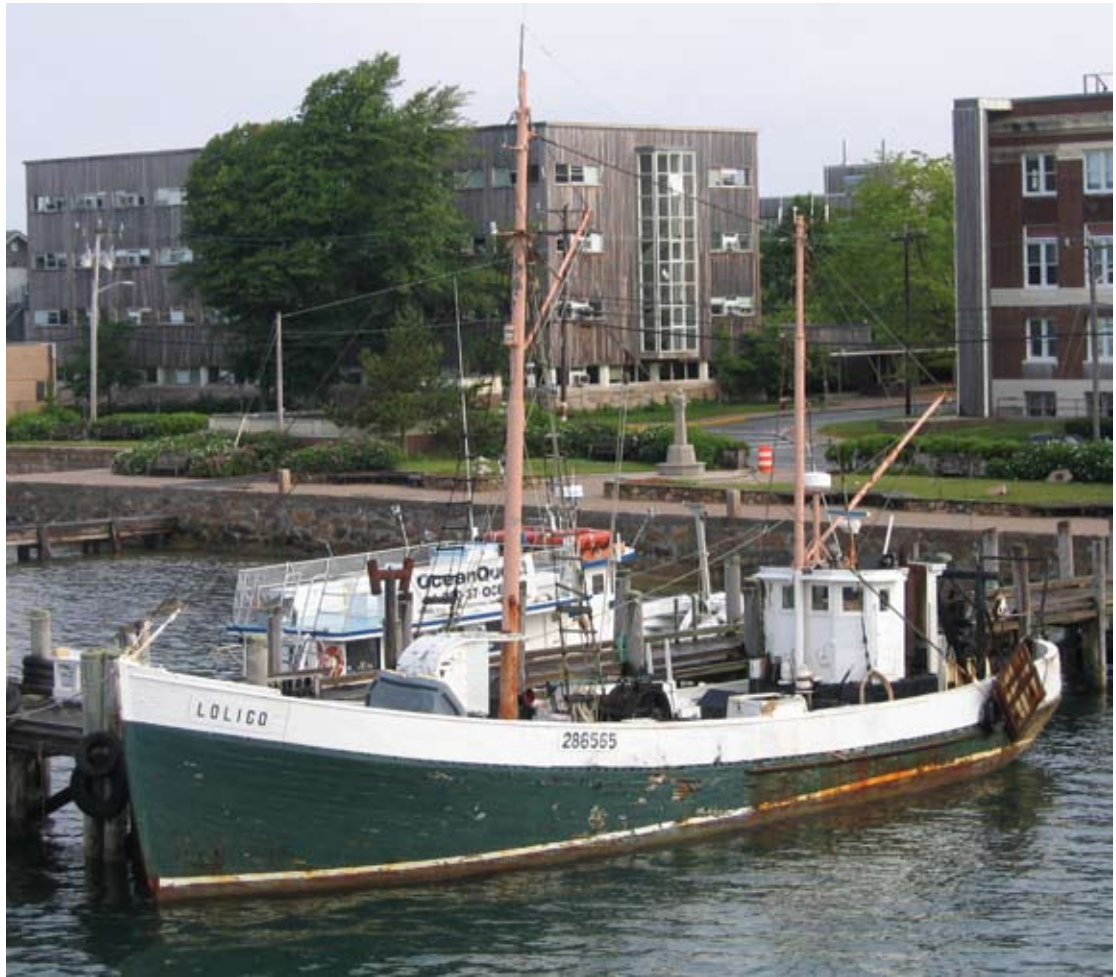
FIGURE 87. MANY EASTERN RIG DRAGGERS SIMILAR TO THE ONE PICTURED HERE SANK WITHIN THE STELLWAGEN BANK SANCTUARY AND ARE BEING DOCUMENTED BY SANCTUARY ARCHAEOLOGISTS.

This style of fishing trawler, common to the waters of Massachusetts Bay in the 20th Century, is a transitional design bridging the gap between earlier wooden sailing schooners and modern-day steel trawlers. Source: NOAA/SBNMS.

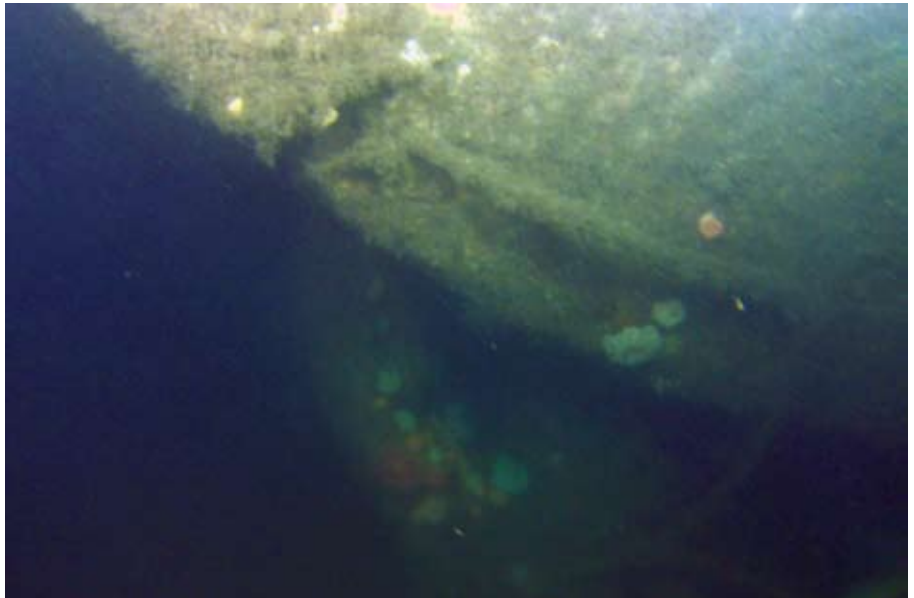
FIGURE 88. WIRE ROPE ASSOCIATED WITH A TRAWL NET CUTS INTO THE STEAMSHIP *PORTLAND'S* BOW.

The negative impacts of commercial fishing activities are well documented on the wreck of the *Portland*. Source: NOAA/SBNMS and NURC-UConn.

Two examples of negative mobile fishing gear impacts are found on the steamship *Portland* and the schooner *Paul Palmer*. The *Portland* has a complete otter trawl net, including rollers and a trawl door, wrapped around its bow and starboard side. The wire tow rope has cut deeply into the steamship's stempost, while one of the trawl doors lies on the main deck (Figure 88). The net is tangled with and extends nearly the length of the starboard side forward of the boiler uptakes. More wire rope is draped across the top of the boiler uptakes. The trawl net has damaged portions of the wreck and greatly hampers the sanctuary's ability to

archaeologically investigate the shipwreck. The net and its wire tow rope present a severe entanglement risk for the ROV vehicle used to study the site.

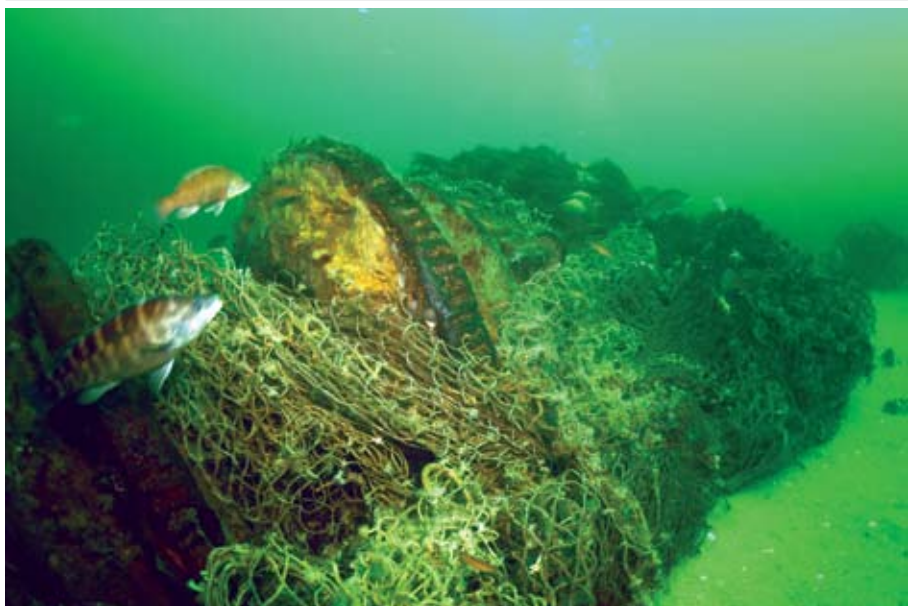
FIGURE 89. THIS LARGE TRAWL NET WAS ONCE WRAPPED AROUND THE SCHOONER *PAUL PALMER'S* WINDLASS, WHERE IT WAS A HAZARD TO SCUBA DIVERS AND MARINE LIFE.

In 2006, NOAA divers removed the net to facilitate the documentation of the schooner's windlass. Courtesy: Tane Casserley, NOAA Maritime Heritage Program.

The schooner *Paul Palmer* also had a trawl net wrapped around its bow. The net and rollers were entangled with the site's windlass and chain pile, and likely altered the orientation of the windlass when it was snagged (Figure 89). The net posed an entanglement hazard for SCUBA divers and marine life. NOAA divers removed the net in September 2006.

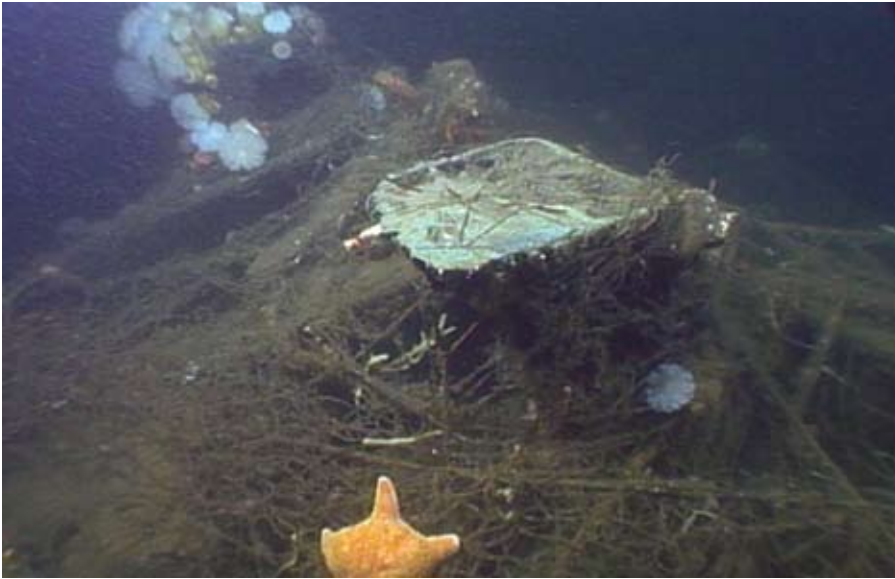
FIGURE 90. GILLNETS COVER THE SCHOONER *LOUISE B. CRARY*'S BOW.

The fishing gear entangled in this shipwreck prevents archaeologists from documenting most of the wreck's bow area and main deck space. Source: NOAA/SBNMS, NURC-UConn and the Science Channel.

Entangled fixed gear continues to degrade the shipwreck by blocking access to the resource. SCUBA divers cannot safely approach the gillnet, for example, and researchers are unable to document the resource and share the information with the public. The *Frank A. Palmer* and *Louise B. Crary* have been negatively impacted by gillnets that are entangled on the shipwrecks. The *Louise B. Crary's* bow is enshrouded with a gillnet that covers the forecastle and forward deck house (Figure 90). The net prevents the archaeological examination of this area. A gill net *also* stretches between the two schooners preventing the archaeological examination of the collision point.

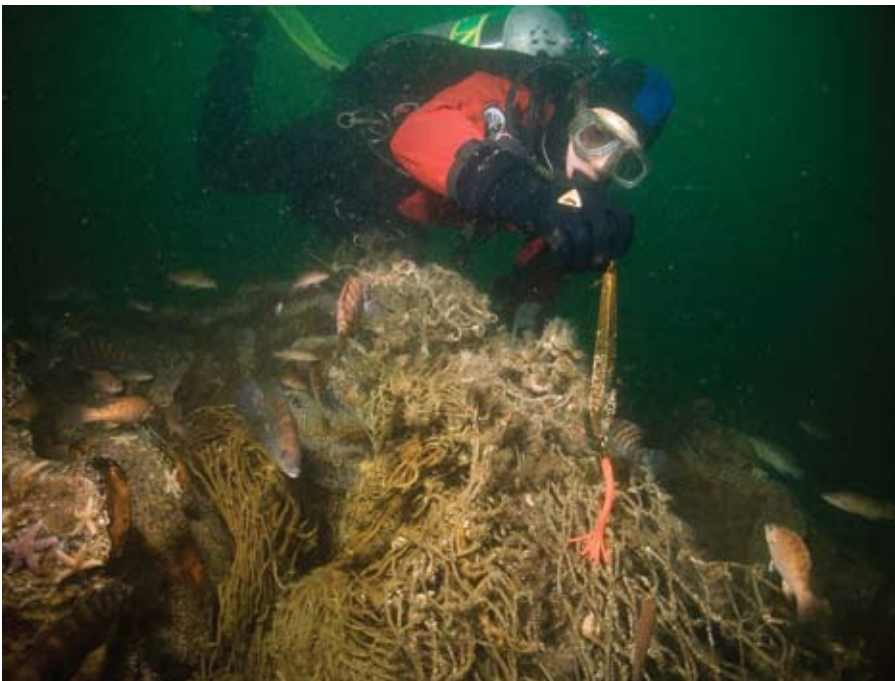
FIGURE 91. JIGS ARE EVIDENCE OF HOOK AND LINE FISHING ACTIVITY ON THE SCHOONER *PAUL PALMER*.

Lost fishing gear poses a hazard to divers and degrades the archaeological integrity of the shipwreck. Source: NOAA/SBNMS.

debris fields. Heavy lead jigs, weighing up to two pounds are repeatedly raised and lowered to attract fish (Figure 91). When a jig comes into contact with a maritime heritage resource, it has the potential to break fragile artifacts made from glass or ceramics. Frequently, fishermen snag their tackle on the shipwreck's structure. Attempts to free the line may damage the resource. If the jig is firmly stuck, the fisherman will break or cut the line, which may then fall across the shipwreck. Lost fishing line limits access to a shipwreck

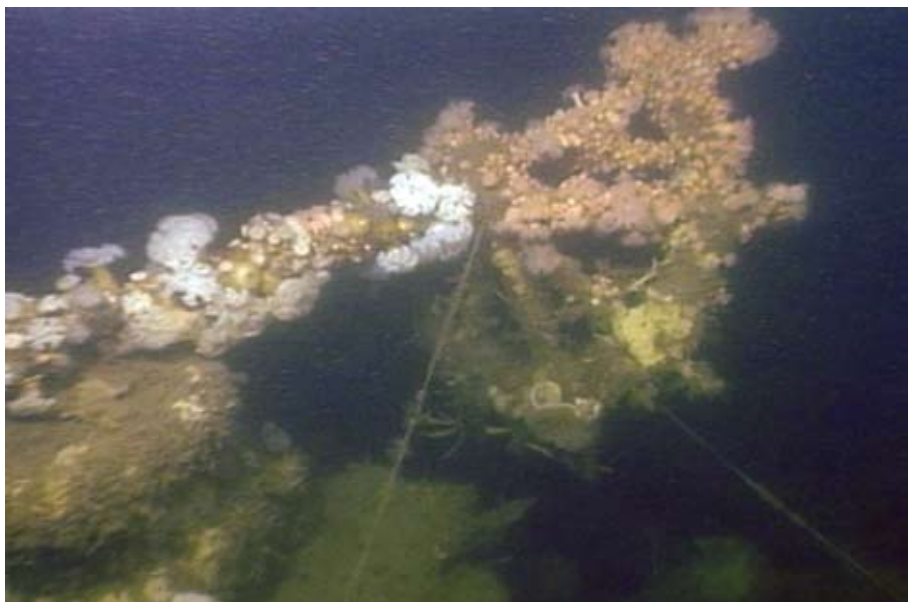
FIGURE 92. BRAIDED AND MONOFILAMENT FISHING LINE IS CAUGHT AROUND THE FRANK A. PALMER’S STEERING WHEEL.

Fishing line stretched across the schooner’s stern prevents the complete documentation of this area, which would provide important information about the vessel’s crew. Source: NOAA/SBNMS and NURC-UConn.

An example of the impact of lost fishing line on a shipwreck is found on the *Frank A. Palmer*. A 2004 archaeological investigation of the site encountered no lost fishing lines crossing the aft deckhouse space. Returning to the same

area in 2005, researchers found several fishing lines crossing the area (Figure 92). The lines prevented the researchers from maneuvering their ROV into the area to investigate the artifacts contained within the cabin. Additionally, an unseen fishing line entangled and fouled a ROV thruster, preventing its operation and forcing termination of the dive.
